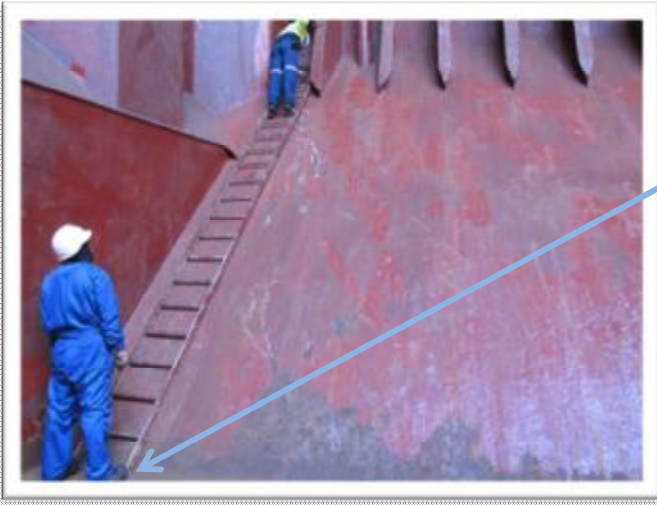
Man at the bottom places both feet at the base of the ladder.

This is safe practice to preventing the ladder sliding on the hopper side.

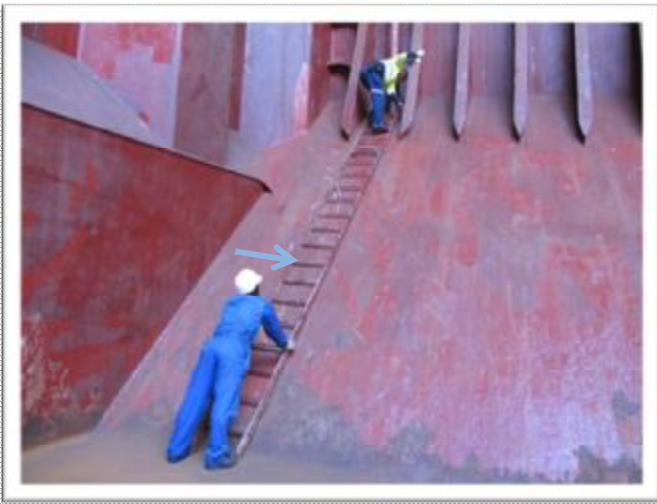
The ladder can be moved and braced at the bottom as the man on the hopper side cleans and checks behind frames

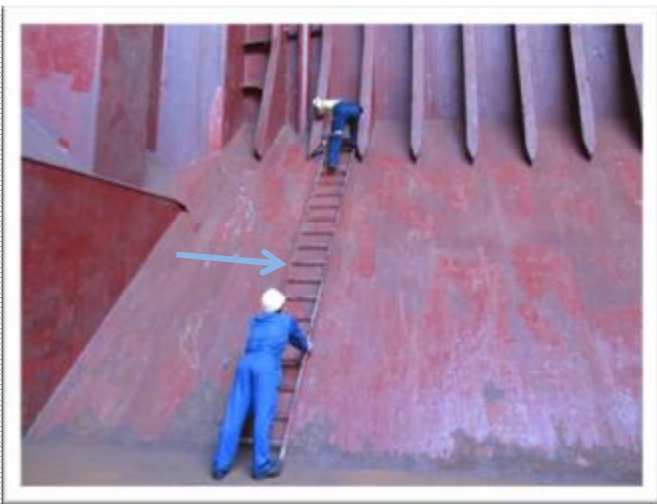
The man at the top should have a paint scraper to remove sheet rust from behind the frames

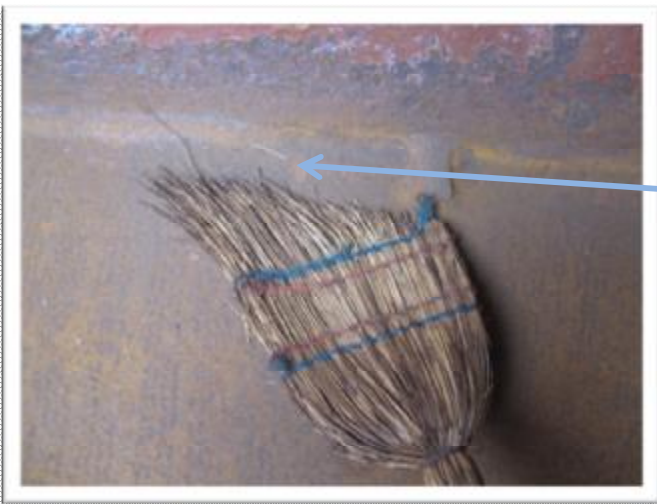
Old straw type brooms should not be used in cleaning as they pose a quarantine issue and also leave behind pieces of straw as they break down. Synthetic brooms or brushes should be used.
