Replacement Campaign of CEJN Female Couplings

SL11-543/PRP
May 2011

Replacement Campaign of CEJN female couplings, series 125

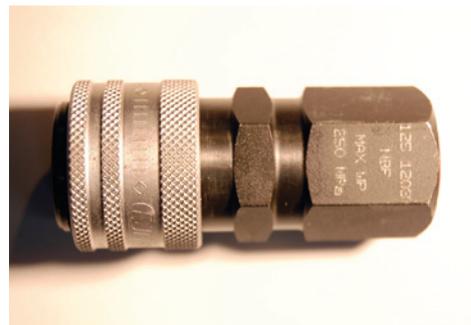
CEJN have after an extensive investigation of 3 recent warranty claims, found couplings where some of the locking balls did not fulfil our specification. After metallurgical analyses of the balls CEJN have established that the heat treatment process has not been done properly by one of our ball suppliers, this improper heat treatment could lead to a material structure that is less tough than the original specification.

Check the number of affected couplings you have in service and on stock and report to your nearest CEJN office no later than 2011-08-31 where shipping of replacement couplings will be taken care of.

As soon as you have received replacement couplings, the replacement of your stock and couplings in service shall be done as soon as possible and return the replaced couplings to your CEJN office.
