Potential Crack in Piston Crown

- in inner circular contact flange

SL2016-626/SBJ September 2016

Owners and operators of MAN B&W two-stroke marine diesel engines. Type: S70MC

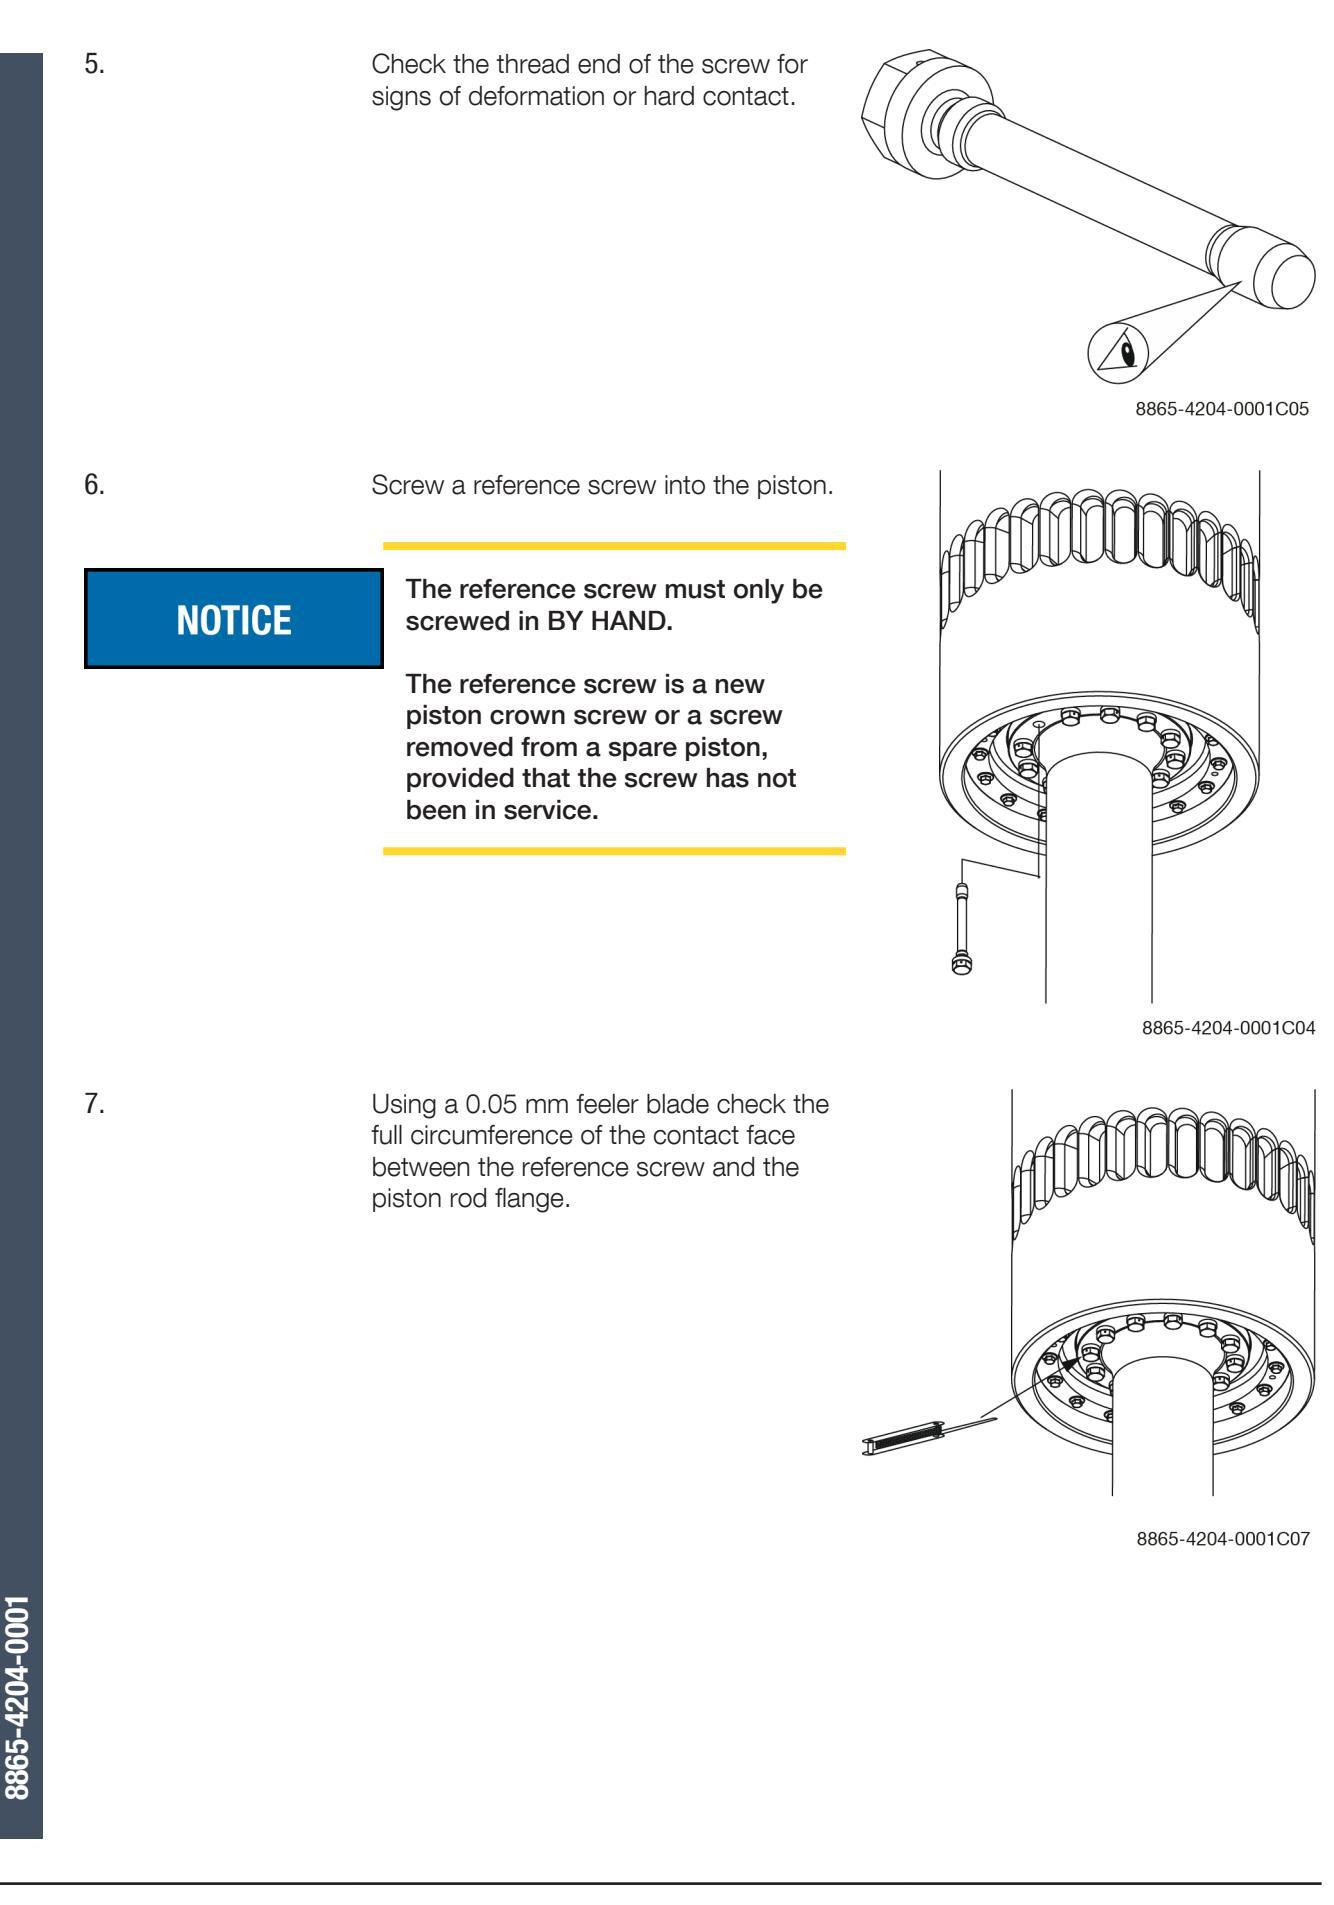
If the screw shows signs of deformation or hard contact, as checked in step 5, OR if a gap is found between the reference screw and the piston rod flange, then the piston MUST be removed from the cylinder as described in the dismantling section of this Sinstruction.

Subsequently the piston crown MUST be scrapped.

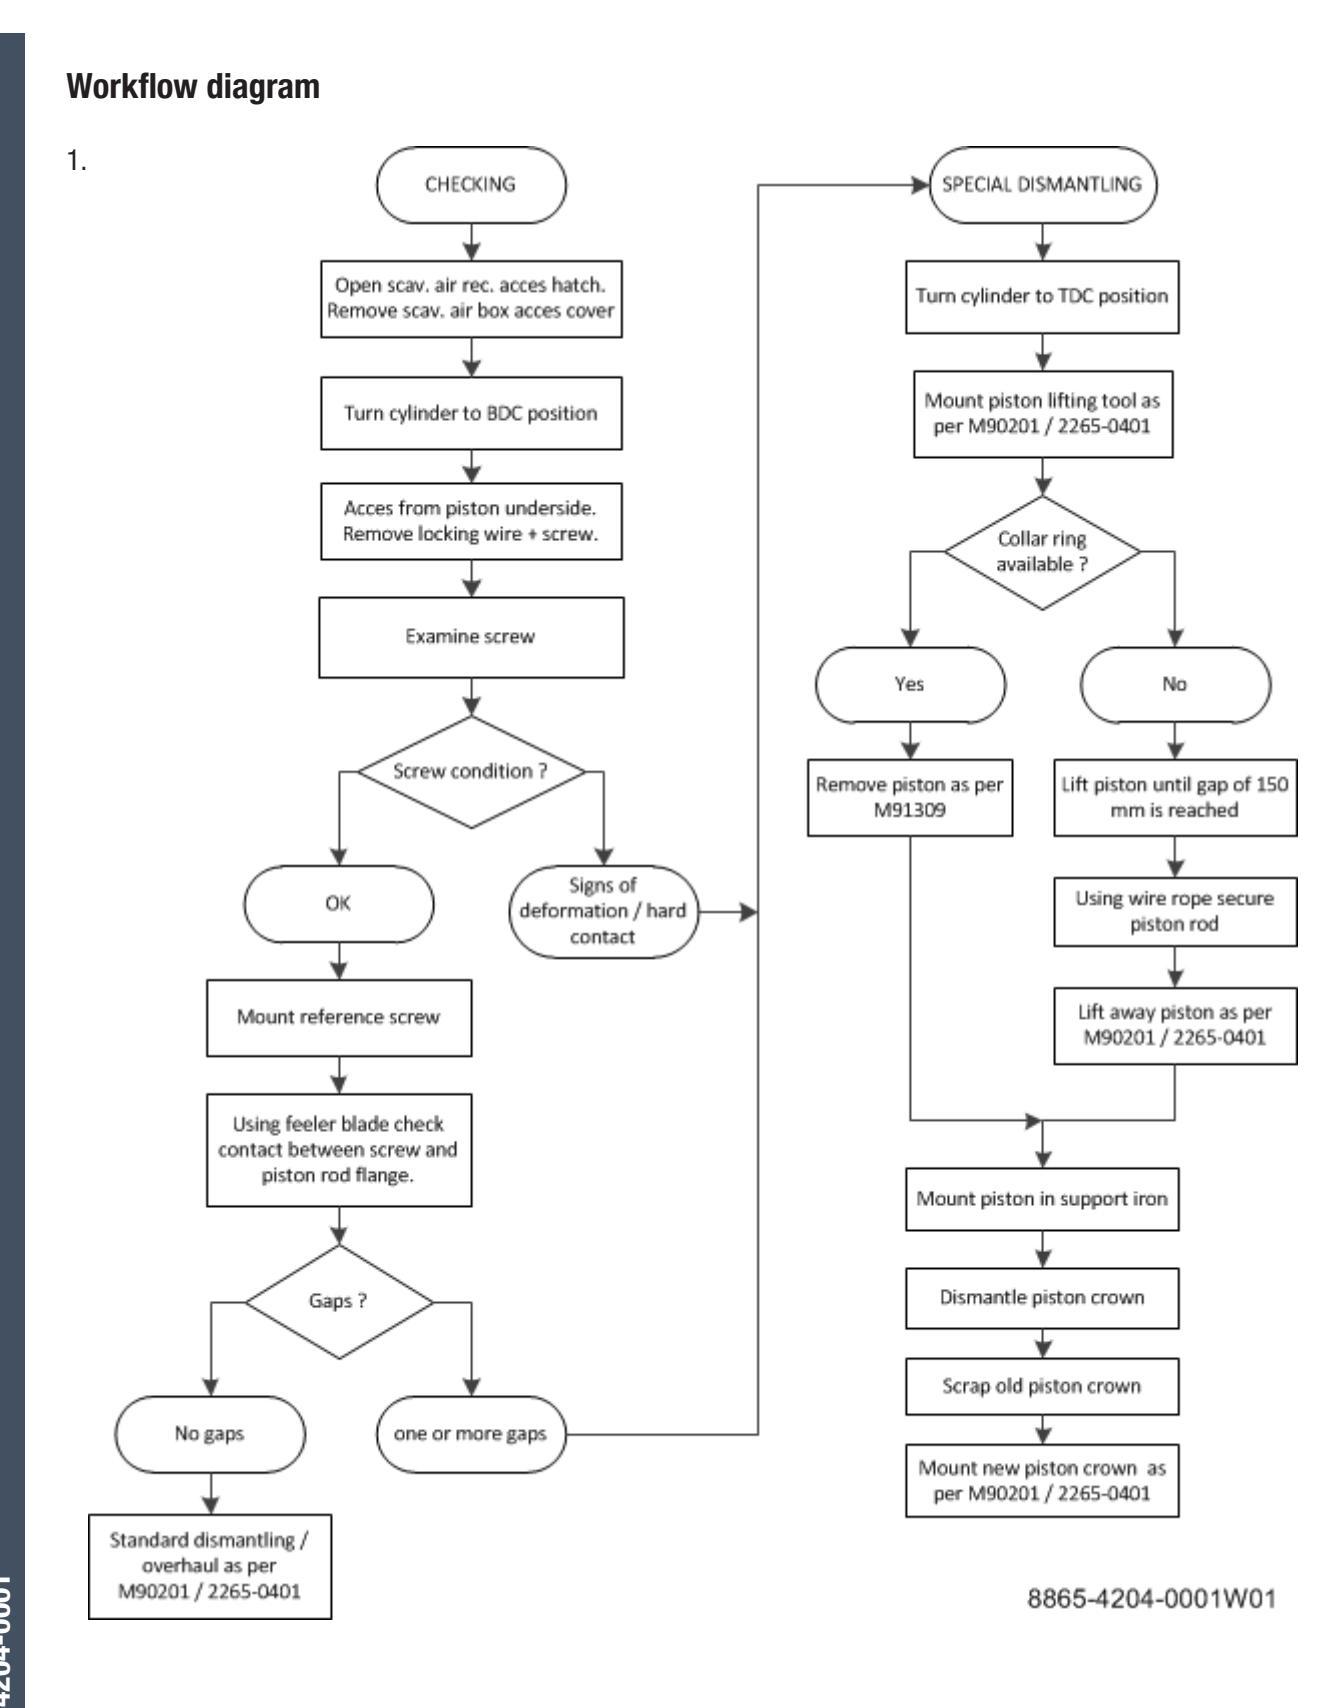
If the screw shows signs of deformation or hard contact OR if a gap is found between the reference screw and the piston rod flange, as described in steps 4 and 6 of the checking section of this S-instruction, then special running with that cylinder cut out of action and the exhaust valve in fixed open position is NOT allowed.

Special running may NOT be carried out until the piston crown of that cylinder has been replaced.
