Service experience with
2020-compliant fuels

Fuel equipment

SL2022-726/KNB
July 2022

Owners and operators of MAN B&W
two-stroke marine combustion engines.
Type: All MAN B&W engines.

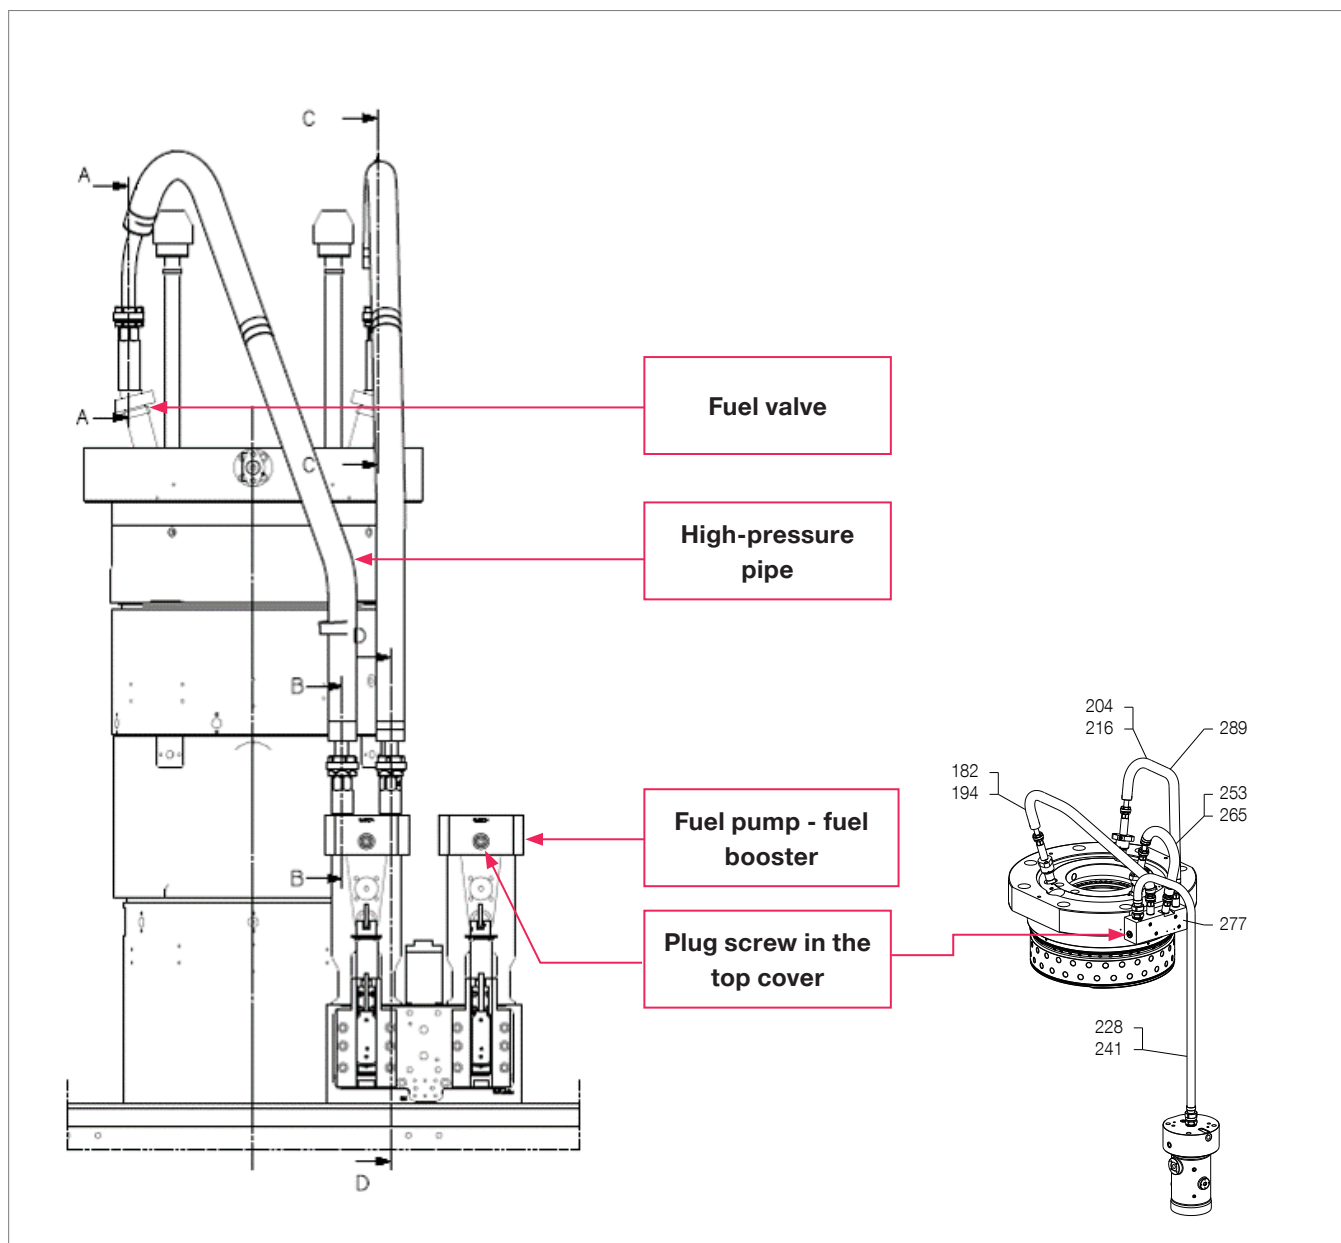
In general, cavitation can occur in both the high-pressure pipes from the fuel booster to the fuel valve and internally in the fuel valves. Fig. 4 shows an overview of the fuel equipment investigated.

Cavitation damage has not been reported for the fuel pump or fuel booster, see Fig. 4.

Fig. 4: Fuel injection equipment

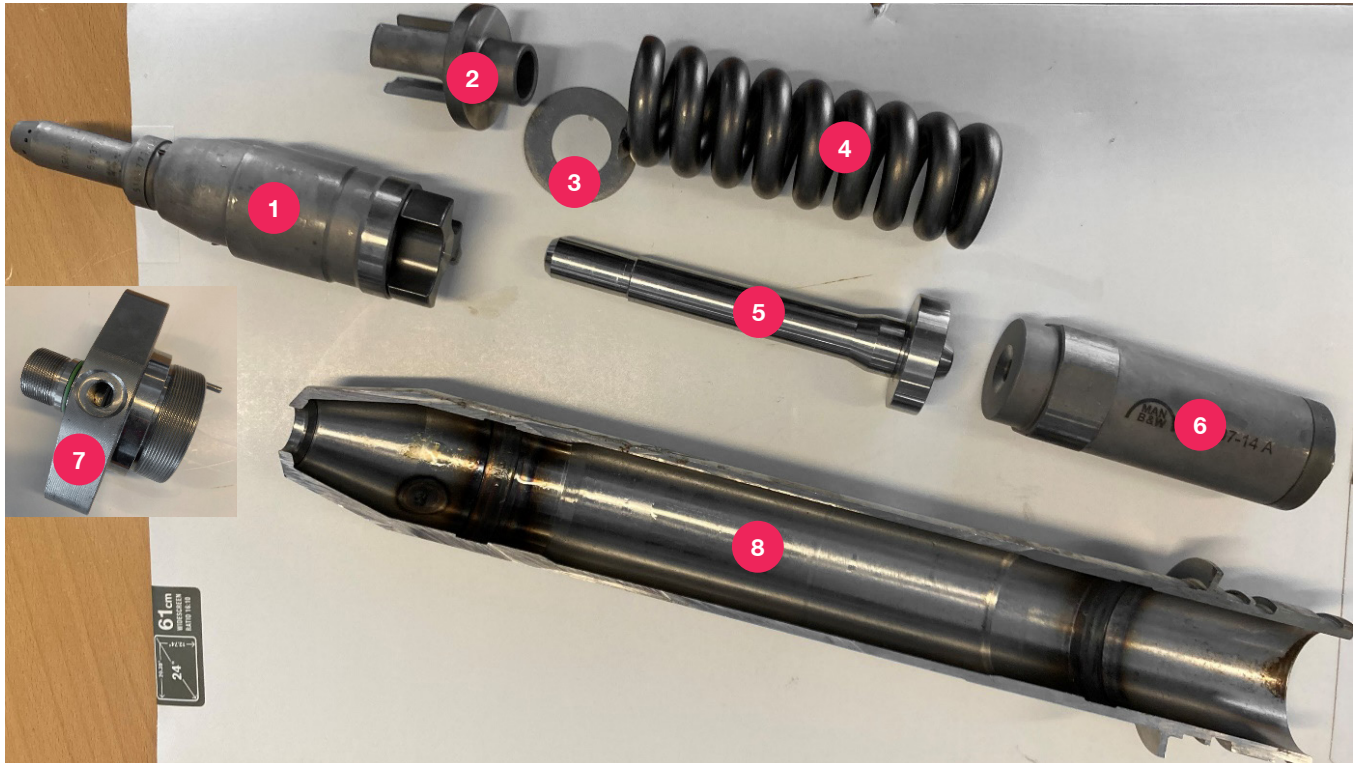
Fig. 6: 1. Spindle guide 2. Foot 3. Shim 4. Spring 5. Thrust spindle pipe 6. Non-return valve 7. Fuel valve head 8. Holder/body

Fuel injection valves may also show signs of cavitation on the internal parts shown in Fig. 6, and as illustrated in Figs. 7-17.

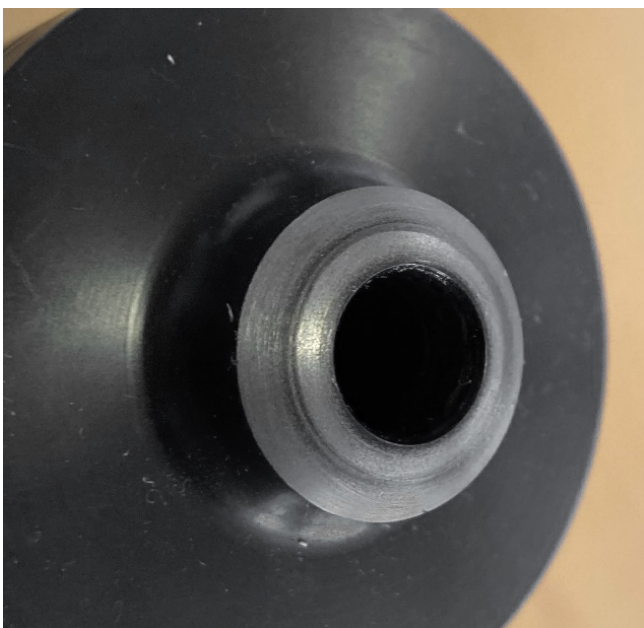
Whereas cavitation is rarely found on the upper end of the non-return valve (Fig. 10), cavitation has been found on the lower end (Fig. 11).

Fig. 10: Cavitation is rarely found at upper end of the non-return valve – towards the fuel valve head – here found in fully functional condition without cavitation

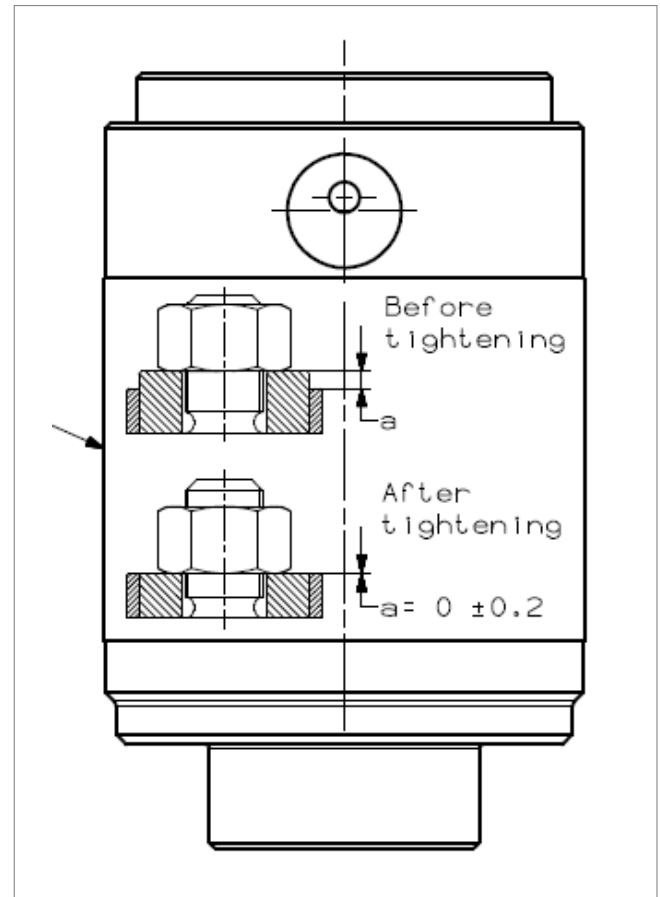
Fig. 18: Spring housing

The spring housing is a wear part that secures the correct tightening force in the engine. If it is not up to acceptable standard, this may have a huge impact on the operation of the fuel valve and the lifetime of internal components.

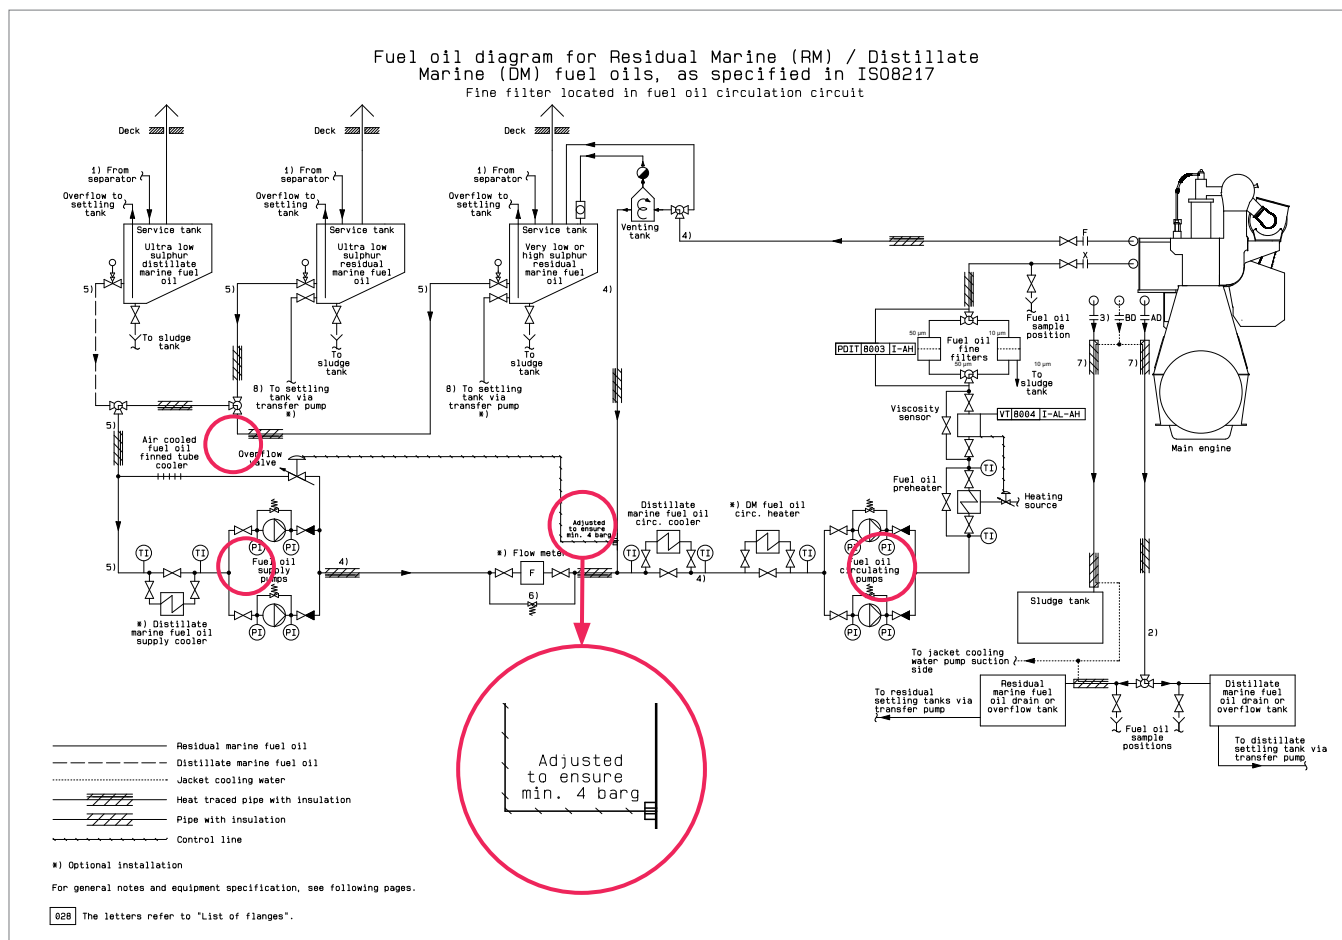
Fig. 19: Fuel oil system

Correct supply and circulation pressures are important to prevent cavitation in the fuel supply system. Fig. 19 shows a fuel oil system with highlighted pressure regulation valves.

<p>Fuel oil supply pumps: Two screw pumps in parallel (one in standby mode)</p> <p>An internal safety/bypass valve is built in (red circle) to prevent damage to the pump housing.</p> <p>Do not adjust this safety valve, as it is preset by the maker. Make sure that it is set correctly according to maker's specification.</p>	Fig. 19.

<p>Pressure regulating valve - Overflow valve: The valve is a proportional type valve designed to measure the pressure from the venting tank to the circulation pumps (but before heater/cooler, etc.). A pressure of 4 bar must be obtained.</p>	Fig. 19.

<p>Fuel oil circulation pumps: Two screw pumps in parallel (one in standby mode)</p> <p>An internal safety/bypass valve is built in (red circle) to prevent damage to the pump housing.</p> <p>Do not adjust this safety valve, it is preset by the maker. Make sure that it is set correctly according to maker's specification – typically 16 bar.</p>	Fig. 19.

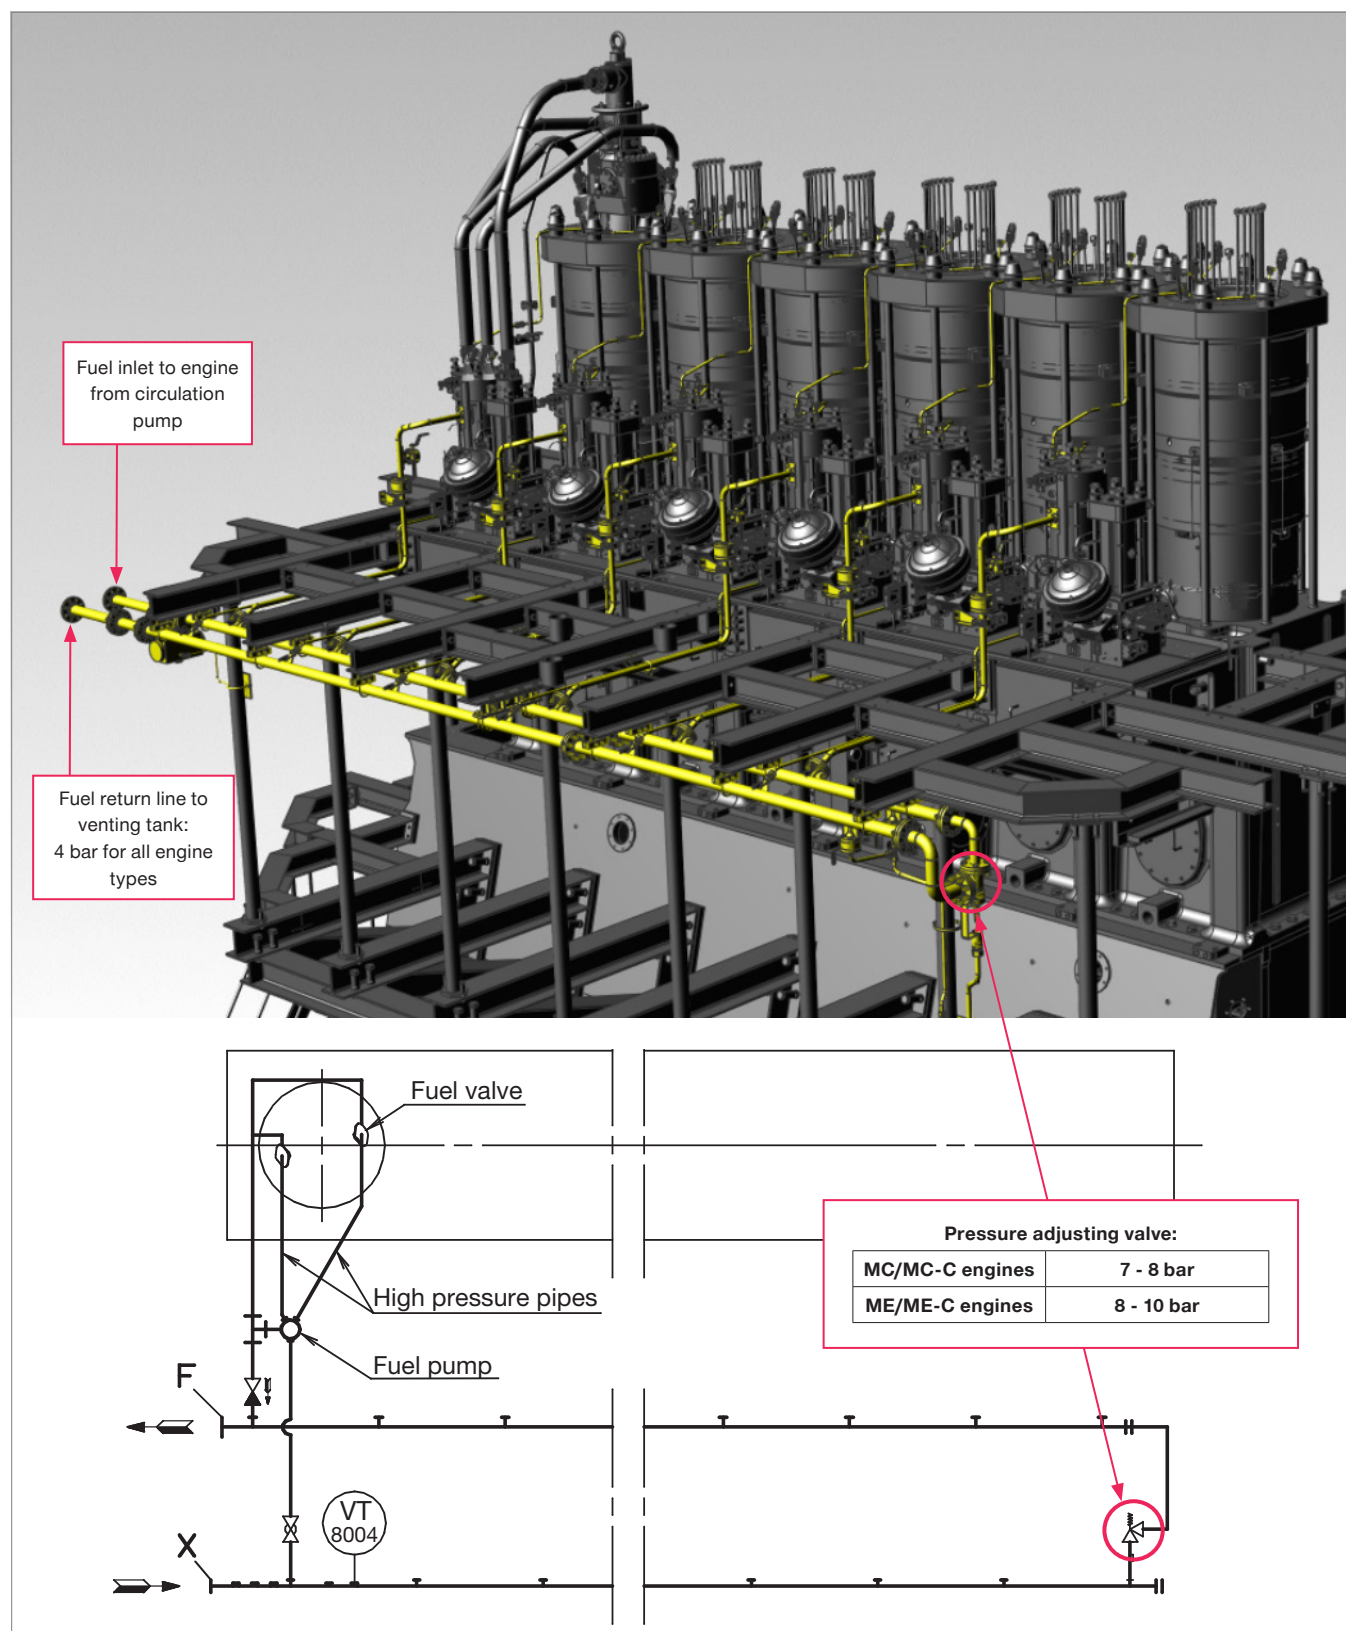
Fig. 20: Fuel circulation on the engine

<p>Pressure adjusting valve: The valve is a proportional type valve that will give a certain pressure deviation from the setpoint throughout the load span of the engine.</p> <p>Incorrect setting of the built-in safety valves in the supply/circulation pump can lead to uncontrolled flow from outlet to inlet at the pump itself.</p> <p>This may lead to fuel pressure pulsation in the circulating system as the engine starts to consume fuel oil.</p>	Fig. 20.

Fig. 20 shows in more detail where the pressure adjusting valve is located in the circulation system close to the engine inlet. Furthermore, the figure gives the different settings depending on engine type.
