YANMAR SERVICE NEWS

Subject	MET18 Turbocharger LO Leakage	No.: 16-2-G-08-012-O Aug. 2016	
Engine Model	6EY18(A)L(W)	Use	Marine Aux. Engines, Industrial
		Engine Nos.	_____

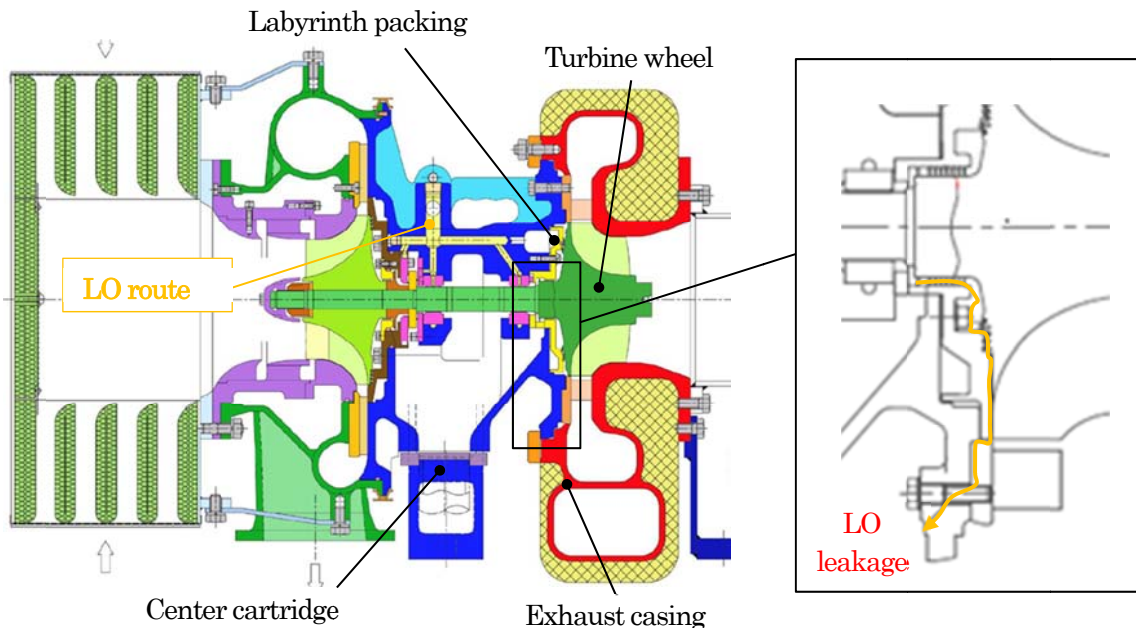
Fig.1 MET18 Turbocharger Section

In the 6EY18 engines, LO leaked from the joint face of the MET18 turbocharger exhaust casing and the center cartridge.

Upon inspection, we found that lube oil leaked from the turbine-side rotor shaft seal,(labyrinth packing).

In this relation, if LO leaked in your turbocharger in a very short time, we recommend the improved labyrinth packing for your use.
