YANMAR SERVICE NEWS

Subject	Rise of Exhaust Gas Temperature	No.: 16-2-G-08-001-O-rev.1 Aug. 2016	
Engine Model	6EY18(A)L(W)	Use	Marine Aux. Engines, Industrial
		Engine Nos.	_____

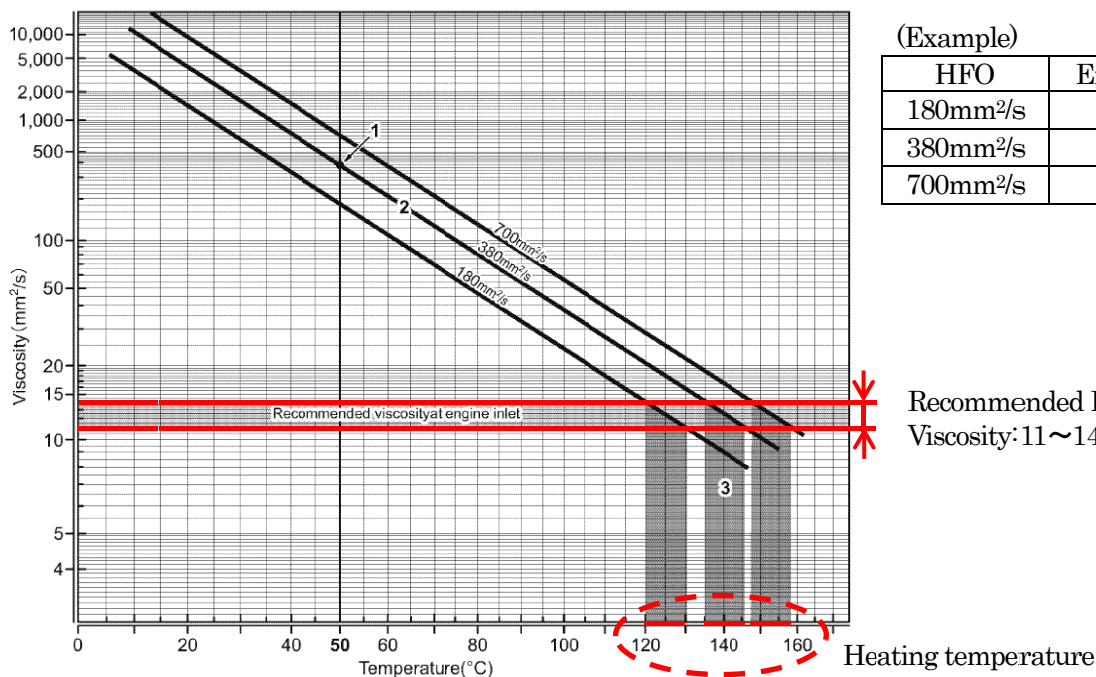
If the engine inlet temperature can't be improved with the adjustment of the setting, it is possible that the balance between the engine inlet pressure, P1, and the return pressure, P2, has collapsed, which has caused the fuel flow volume to the engine to be insufficient, (see Fig.1 below). In this case, adjust the respective pressure regulating valve to obtain the following pressure:

Pressure Setting of Hull-mount Pressure Regulating Valve, P2 \geq Engine Inlet Pressure, P3+0.05MPa

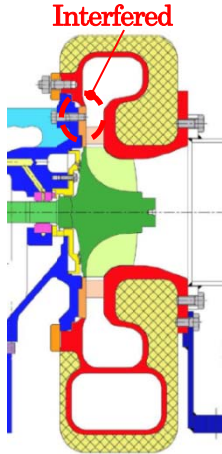
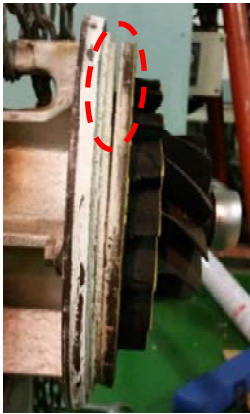
Cause	Improvement
<p>【Corrosion Wastage of Nozzle Ring】 Nozzle ring caused corrosion wastage due to high oxidation corrosion, which contributed to increase the Clearance Q.</p>

<p>【Nozzle Ring Material and External Diameter Change】</p> <ul style="list-style-type: none"> · In order to increase acid resistance, heat resistance and extreme temperature strength, the material was changed as follows: SS400(machined) → SCS1(casted) · In an aim to avoid interference caused by thermal expansion, the external diameter was diminished by 0.2mm. <p>【Discrimination】 Check the mfg. number punched on the nozzle ring surface and the rear casting surface.</p>
<p>【Nozzle ring rolled back】 As a result of FEM analysis, we found that the exhaust casing interfered with the nozzle ring outer circumference due to thermal expansion to cause distortion. However, this failure is corrected upon installing the exhaust casing. Accordingly, this factor gives only very small effect to the turbocharger performance drop.</p>

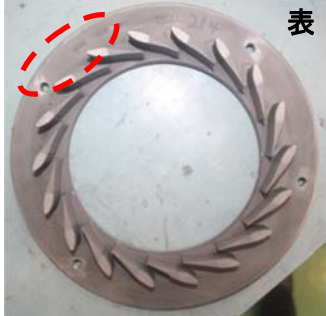
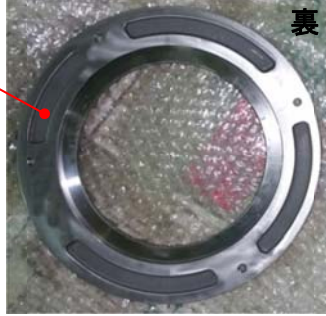
<p>Casting surface (4 positions)</p>

<p>(Example) <u>JPC-1234</u> ↓ Improved type</p>

<p>【Applicable Engine No.】 7249~7251,7371~7385,7389~7403,7407~7409, 7416~7419,7433~7441,7446~7448,7452~7454, 7458~7466,7473~7490,7494~</p>
