**Excessive wear on the locking keys of crankshaft thrust bearing**

SL2022-721/JNN  
January 2022

Owners and operators of  
MAN four-stroke engines.

Marine: L27/38

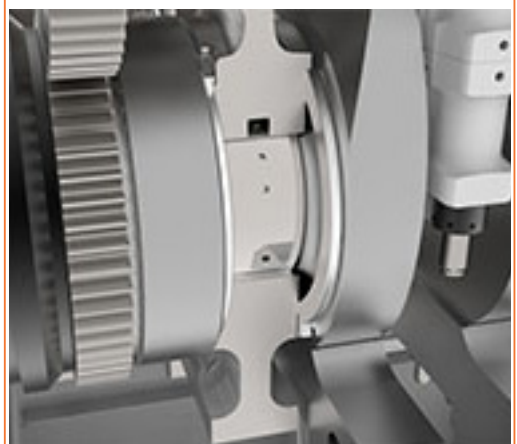
Figure 1.

As is shown in Figure 1 on page two, the thrust bearings are positioned on each side of the aft end main bearing, and the inspection can be done easily via the crankcase doors.

We recommend to carry out a visual inspection of the locking keys on the thrust bearing rings at the first opportunity.
