## Fleet Advisory 2024-01 (Accumulated advisories of last years)

Fleet advisory 2023-02: AMSA PSC deficiencies at Fremantle on 03 Feb

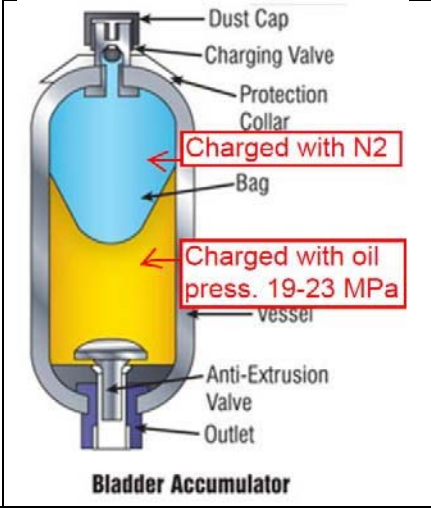
<p><b>Bladder Accumulator</b></p>

Code	Description
11113	<p><b>Rescue boat unable to be launched using accumulator.</b></p> <p>Comments:</p> <ul style="list-style-type: none"><li>• AMSA inspector instructed the crew to swing the rescue boat davit by means of accumulator. The davit only moved to about 30 degrees and the pressure from the accumulator dropped down to zero. The investigations revealed that there was no nitrogen gas in the cylinder as it ruptured the internal bladder.</li><li>• New accumulator was ordered and installed in place.</li><li>• Test rescue boat davit operation on all modes – electric/accumulator/manual handle during monthly drill and revert with the result to your Ship Manager. Ensure all three modes operating instructions are displayed and crew is trained to operate davit by all three modes.</li><li>• Ensure accumulator pressure is maintained as per the manufacturer's manual. Check maker's manual of your vessel in this regard.</li><li>• <b>As per the inspected ship maker's manual:</b><ul style="list-style-type: none"><li>➤ The charging pressure of accumulator is to be kept 8 MPa (80 bar) and accumulator is to be charged with nitrogen if pressure falls below 8 MPa. There is a bladder (an elastic bag) inside the cylindrical unit which is charged with nitrogen gas.</li><li>➤ The accumulator pressure is to be kept in the range of 19 – 23 MPa (190-230 bar). This pressure in the accumulator is maintained by automatically controlled electric pump. When accumulator pressure falls below 19 MPa, pump charges the pressure to 23 MPa with the hydraulic oil.</li></ul></li><li>• There is to be always one 230 Bar 50 litre Nitrogen bottle ready for use. Please order if it is not on board. There is a specific fitting with gauge that is needed to fill Nitrogen. Ships are to order this from their manual. Stow this item in the safety locker properly labelled/marked.</li><li>• The accumulator shall be serviced/bladder renewed ashore at 5 yearly intervals during dry docking.</li></ul> <p>Accumulator (General picture for understanding, not ship specific)</p>
