Fleet Advisory 2025-01 (Accumulated fleet advisories of 2024)

#### Fleet Advisory 2024-02

PSC deficiencies in Tianjin, China on 08 April 2024

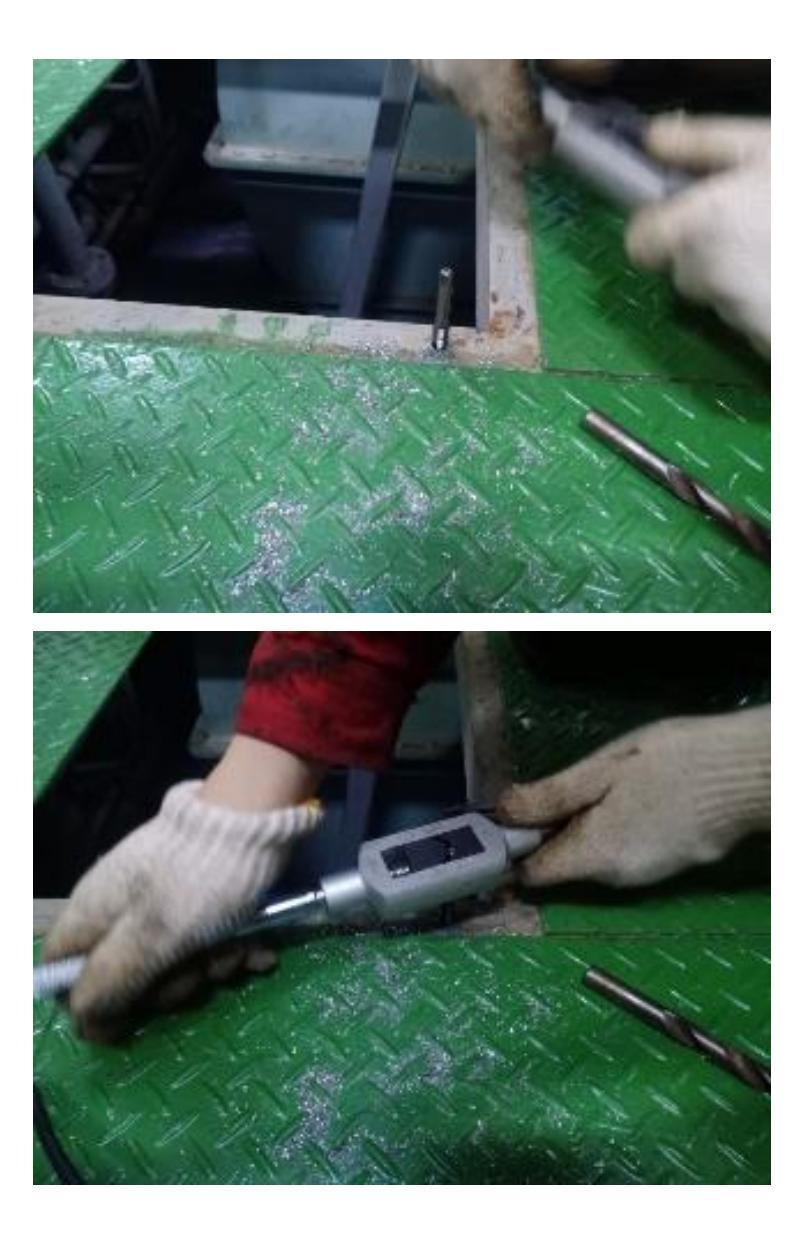
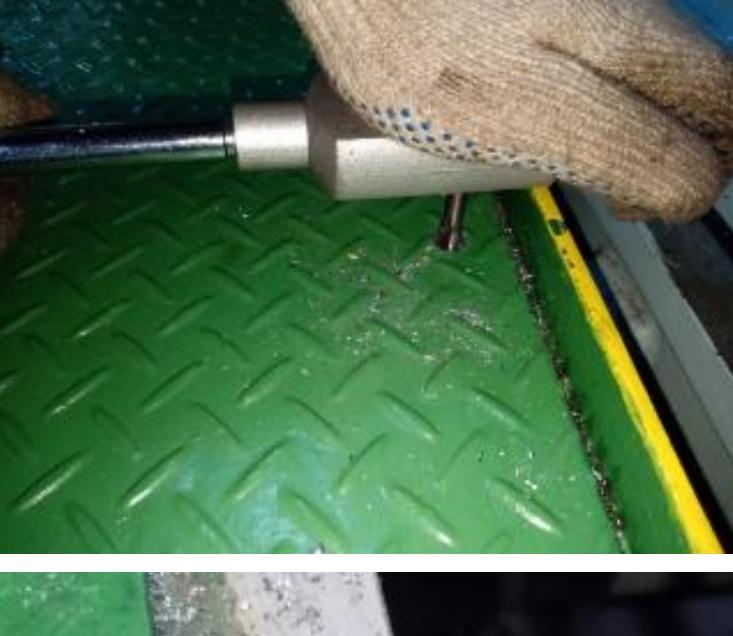
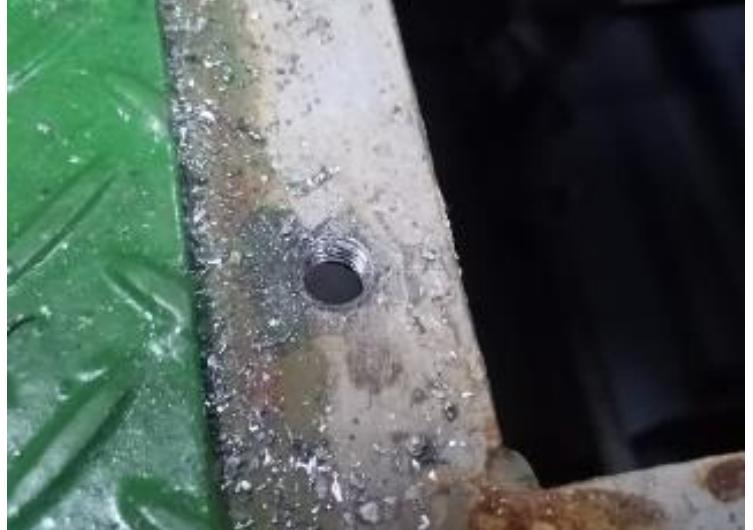
Code	Description
	<b>DEFICIENCY</b> - Floor Plates in Engine room not secured or properly fastened. As per PSCO requirement, the floor plates in ER should be secured on the frame to avoid shifting in case of ship rolling & pitching at sea / listing / flooding.
	<b>Company comments</b> : It was observed that many vessels were delivered from the shipyard and the floor plates were not secured.
	<ul> <li>Root cause:</li> <li>Inadequate design</li> <li>Lack of situational awareness</li> <li>Inadequate identification of hazards</li> </ul>
	<ul> <li>Preventive Actions:</li> <li>The Engine room floor plates should be secured on the frame to avoid injury to the crew .</li> <li>The floor plates may shift due to <ul> <li>a) heavy rolling and pitching at sea</li> <li>b) listing of ship during cargo operations in port</li> <li>c) flooding of engine room (water sloshing the bilge area due to rolling creating a hydraulic hammer and forcing the deck plates upwards)</li> </ul> </li> </ul>

Use the M20 straight twist drill to chamfer the hole on the plate.

# Tap the drilled holes on each frame with M10 hand tap.

# Secure the plates with M10 countersunk screws.
