<p>HEALTH, SAFETY, ENVIRONMENT AND QUALITY MANAGEMENT SYSTEM</p> <p>15.0. POLLUTION PREVENTION</p> <p>DRY CARGO MANUAL</p>	<p>Sect : 15.0 Page : 1 of 4 Date : 7-Aug-25 Rev : 10.2 Appr : DPA</p>
---	---	--

POLLUTION PREVENTION

1. SCUPPER PLUGS¹

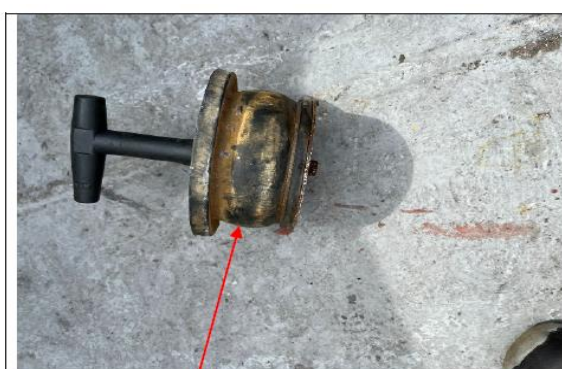
Diaphragm is not compressing/inflating on turning the tightening knob

- The plugs were not effectively tightened,
- The plugs were loosely fitted in the scupper hole and came out easily when pulled up.
- The plugs were defective, and the rubber diaphragm was not compressing upon turning the knob.
- The plug couldn't be tightened due to the turning lever being obstructed by the guard rail stay.⁶

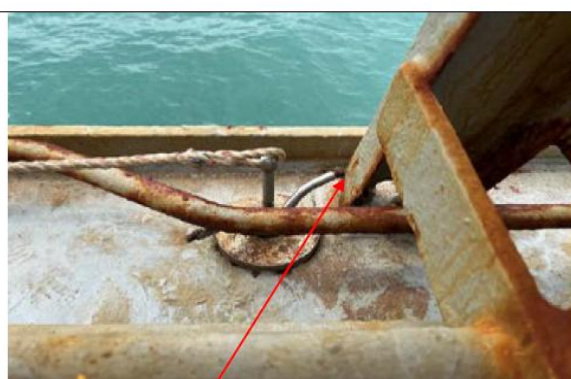
Unable to tighten the plug due to obstruction for turning lever

Plugs that cannot be tightened due to design constraints, shall be identified, and the securing system modified to allow the scupper to be inflated as required. Crew must be instructed to use these modified scupper plugs in the correct positions. One method is to colour code the difficult spots with a correspondingly colour marked scupper plug.⁸

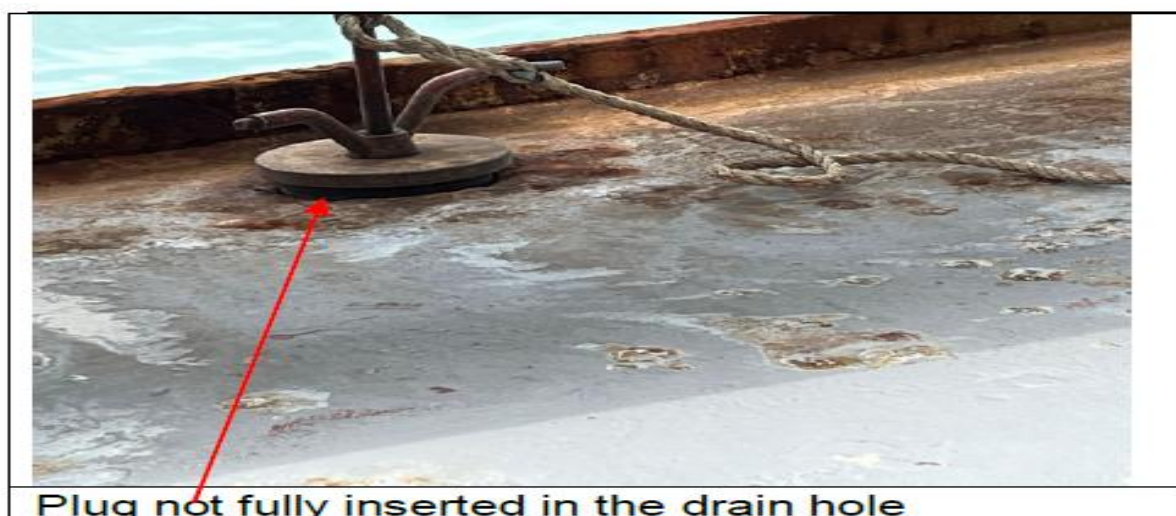
The scupper plug must be tightened until some resistance is felt so that the rubber diaphragm seals the scupper hole effectively. The plugs are inserted in place by the duty deck rating, but the duty officer must cross check to ensure that scupper plugs are effectively sealed.⁷
