Service Letter

SL07-488/PMN
November 2007

Work Inside Cylinder Liners

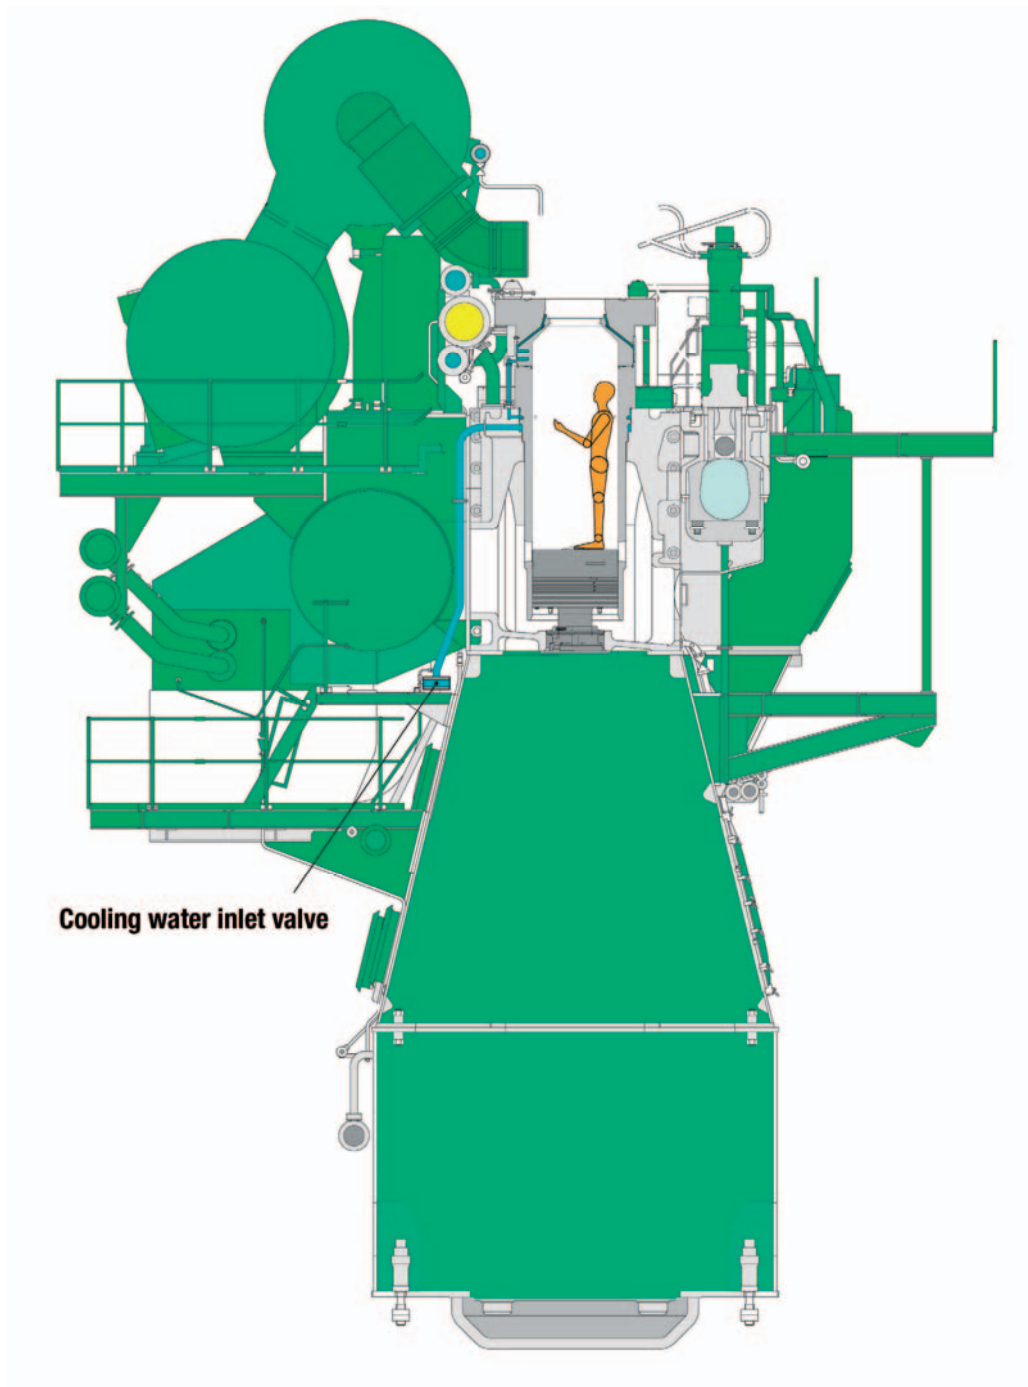
During modification work inside the cylinder liner on a K90MC engine, only the exhaust valve had been removed to allow access into the cylinder liner. One fitter was inside the liner when cooling water was admitted by accident, see Encl. 1.

The cooling water entered the combustion chamber from the bores in the cylinder cover, where cooling water passes from the cylinder cover to the exhaust valve. Further to normal precautions practices and safety procedures, we therefore stress the following:

**Person working inside a cylinder liner
with cylinder cover mounted**

For any work, inspection or cleaning inside a cylinder liner, the cylinder cover **must** always be removed before entering. A cylinder liner should never be entered by only removing the exhaust valve and gain access by either standing on the piston and turning, or by climbing down a ladder through the bore in the cylinder cover.

A safety assistant **must**, at all times, be present outside the cylinder liner and be in constant contact with the person working inside the cylinder liner.

A ladder **must** be present in order for the person inside the liner to be able to escape even in the event of a power failure.
