Commonly occurring PSC deficiencies related to fire dampers

**VENTILATION MAINTENANCE CAMPAIGN**

**JUL 2017**

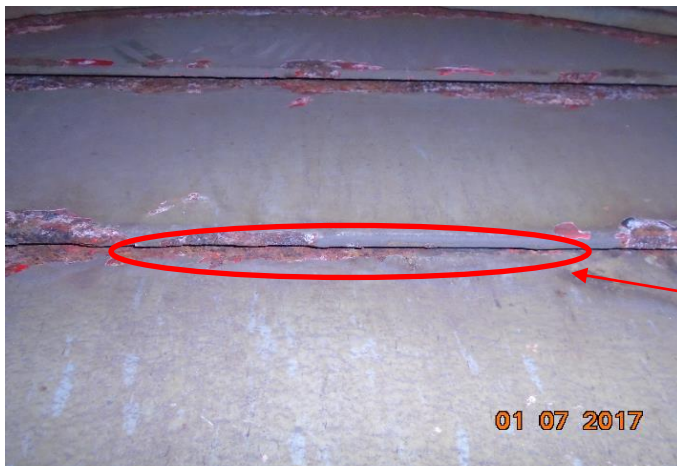
Holes / heavy corrosion on damper housing and flaps

- Ensure damper flap edges are not wasted
- Ensure damper flaps seal effectively
- The mushroom heads need to be removed and the insides / flaps painted, including new vessels.

- Flame screens are to thoroughly cleaned or renewed if required.
